CENTURY ASPHALT ROCK CRUSHER HOUSTON, TX

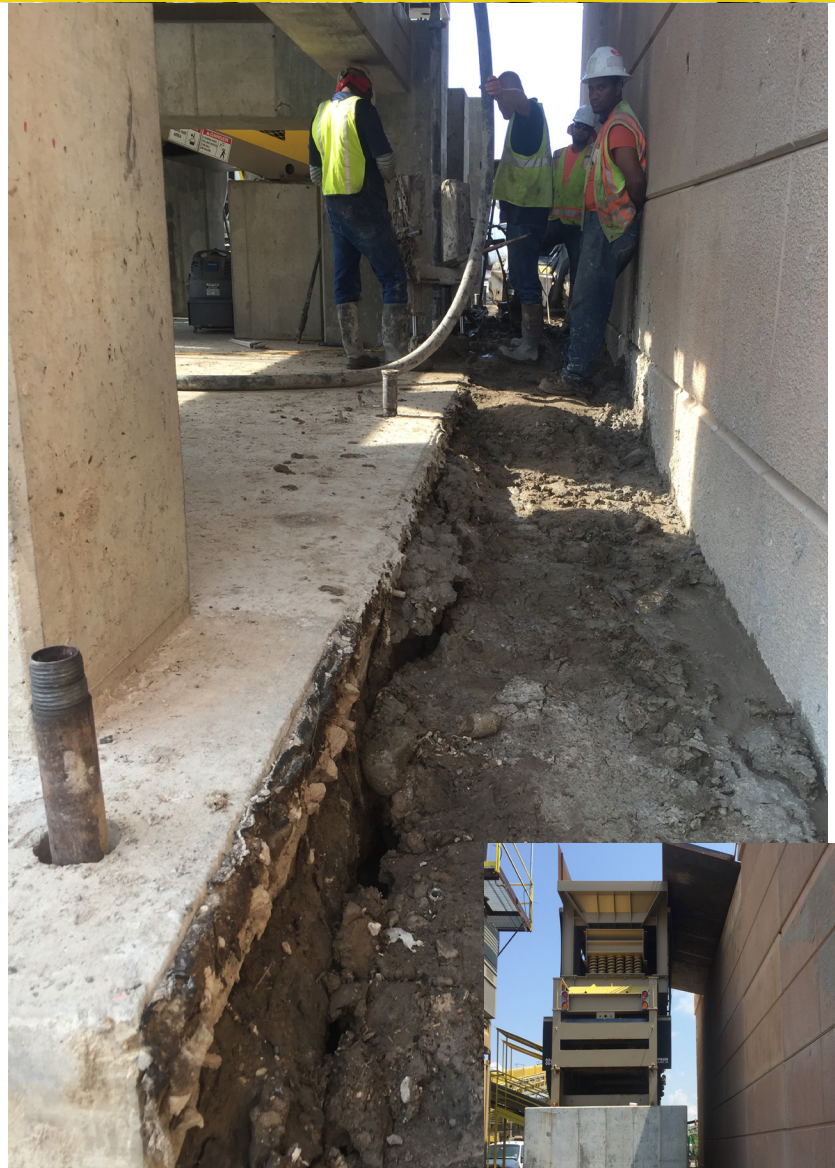
Century Asphalt constructed a new asphalt plant in Houston, TX. The site had previously been a landfill. The foundation design to support the rock crusher was a 50FT long x 14FT wide x 5FT thick concrete pad with concrete columns extending upwards to set the rock crusher on. The total weight of the concrete foundation with rock crusher was approximately 750,000 pounds. Once the rock crusher was placed into operation, the structure settled 14 inches in one area and was twisted out of level to various degrees throughout the remainder of the foundation. The settlement issue occurred due to continual intense vibration of the rock crusher, while in operation, exposing the weak subgrade beneath the foundation. Low overhead clearance, to access the foundation and perform the work further complicated the repair process. In addition, it was of critical importance that the foundation be within an 1/8-inch tolerance of level throughout, due to the operating specifications of the rock crusher.

Superior Grouting was contracted to stabilize and level the rock crusher foundation utilizing the upstage compaction grouting process. Testing was performed to determine the depth of load bearing soils. Two-inch ID, high-pressure seamless pipe, were set to a 32FT depth on an approximate 5FT grid pattern. A low mobility 0 to 1-inch slump, cement-based grout, was injected at high pressure to densify the existing subgrade soils. The process was repeated in 2FT lifts to the top of the grout zone. The foundation was monitored for lift continuously throughout the process. The approximately 750,000-pound structure was stabilized and raised to within the required tolerance.
