VDOT Culvert Rehabilitation – Dan River Church Road, VA

Lynchburg District, Halifax Residency, Dan River Church Rd (36°43'35.2"N 78°52'14.1"W)
45' of 24" round CMP under Dan River Church Rd, structural pipe restoration.

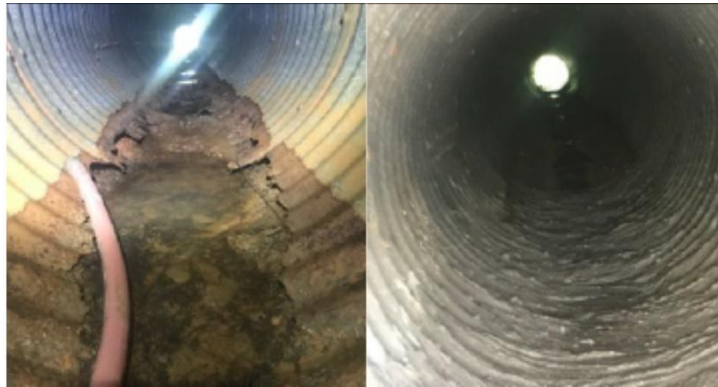
The project involved spraying a structural liner inside of a deteriorated, galvanized corrugated steel culvert. Due to corrosion, the structural bearing capacity of the culvert had been compromised and an engineered solution to carry the load of vehicular traffic was needed. A solution which did not disrupt traffic and, simultaneously, minimized flow reduction was required. The chosen method of rehabilitation involved utilizing Nukote PP300 and Nukote ST-M to create a structural, composite liner.

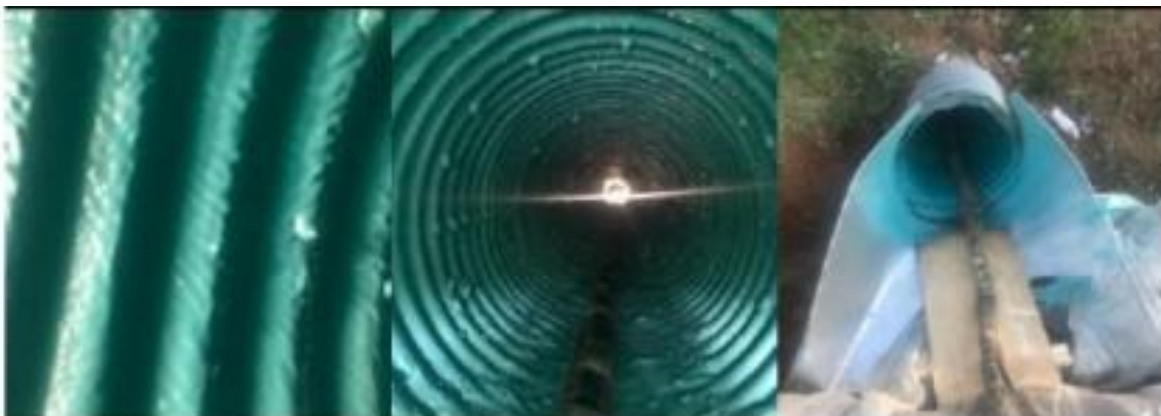
Host pipe was dewatered and cleaned. Multiple areas of the invert were missing and required repair/filling. After repairs were performed, the pipe was cleaned again, dried and the ends of the pipe were primed. The entire pipe was coated lightly with ST-M (~30 mils) using Ringtech 360 system. PP300 (1050mils) was then applied using the Ringtech 360 system. ST-M (150mils) topcoat was then applied with Ringtech 360.

VDOT installed an upstream wing which was cleaned, primed and coated with ST-M manually to be monolithic with the structural top coating.
